National Highway Traffic Safety Administration

Case Vehicle (A): 2000 Chevrolet Type: Tracker 4 x 4, 4-door SUV

Driver: 69-year-old female

CDC: 12-FDMW-1, 12-LZAS-2, 12-FLEE-3, 00-UYLN-2, 03-RZAW-3

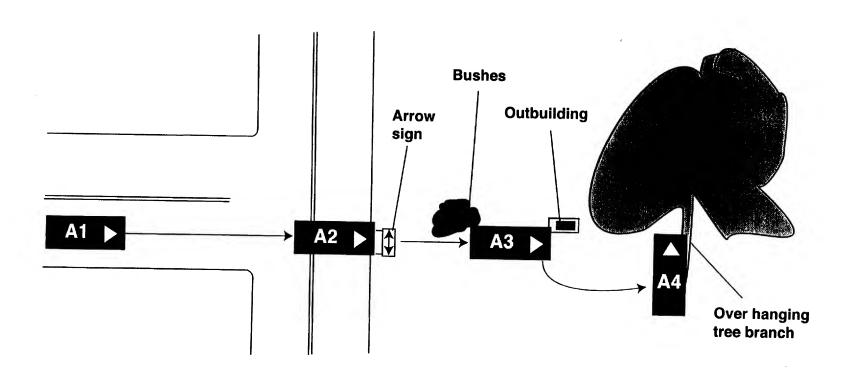
ACCIDENT DESCRIPTION: Case vehicle (A) was traveling east, At A CASE VEHICLE (A): 2000 Chevrokt	Tracken
T-type intersection the vahish went stepicht. Case OTHER VEHICLE (P)	•
vehicle (A) exited the east edge of the noad, stauch a THIRD VEHICLE (C):	
SIGN with its trout, sideswiped a bush with its left side, struck a nut	
building with its left-thout, then notated countenclockwise and struck	
A ovenhanging tree branch with its right side.	
	NORTH

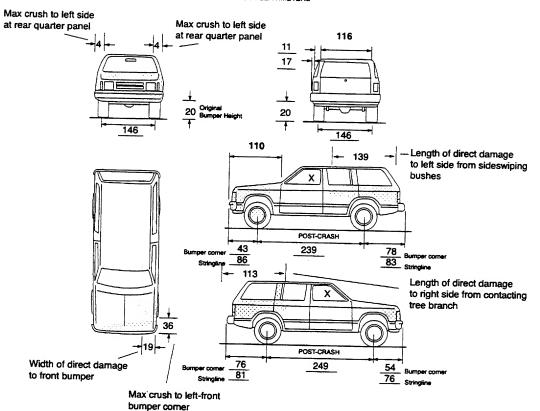
VEHICLE DAMAGE

(Slide 10) Overall damage to case vehicle (A) was moderate. (Slide 11) Direct contact damage to the front from contact with the outbuilding began at the left bumper corner and extended 19 cm to the right, resulting in 17-percent vehicle overlap. The maximum crush was 28 cm to the left-front bumper corner.

Left-side damage from side swiping the bushes began at the left-rear bumper corner and extended 139-cm forward. The maximum crush to the left side was 4 cm at the fender. Additionally, (slide 18) the left fender was torn open and crushed rearward from impact with the road sign pole, and (slide 19) the left-front wheel was damaged due to impact with the outbuilding. (Slides 20 and 21) The left upper and lower A- and C-pillars, the left-front roof area, the left roof siderail, both left doors, and the left quarter panel were damaged. The left-front door window glass was broken out. (Slide 22) The lower steering control arm was broken loose, and the left wheelbase was reduced 9 cm.

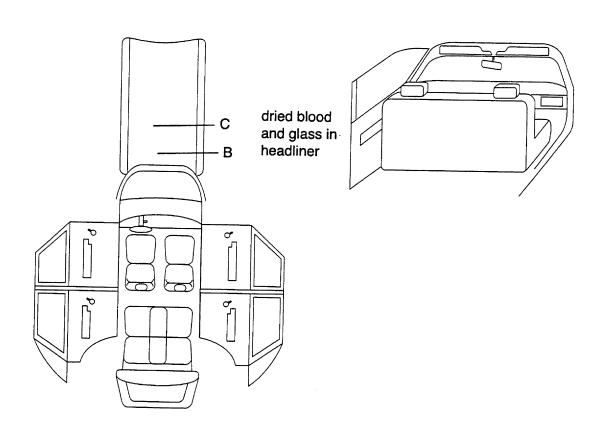
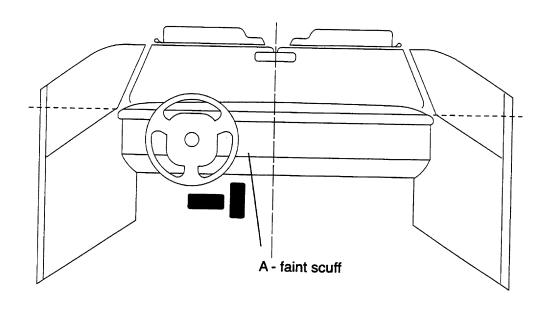
Location	Component	Distance (cm)	Direction
Left side (slide 38)	toepan	14	to rear

In addition, (slide 39) the left foot pad was knocked out of its mount and deflected to the left, the brake pedal was pushed rearward, and the gas pedal was deflected to the right by toepan intrusion, caused by direct contact with the concrete foundation. (Slide 40) The driver's seat was rotated to the left and the center console was rotated to the right. (Slides 41, 42 and 43) There was no other interior damage.

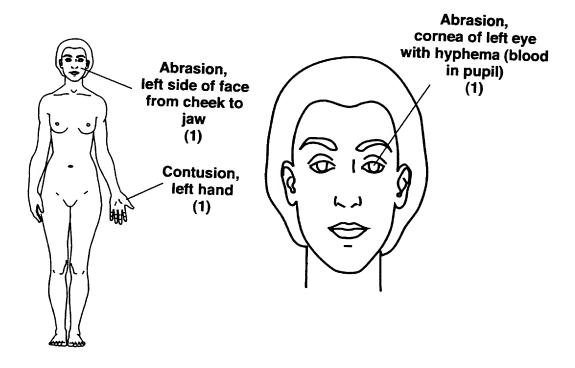
INDICATE LOCATION OF INJURIES.

Injury Source		
Injury Description	A.I.S.	Definite	Probable	Possible
Abrasion, cornea of left eye with hyphema (blood in pupil)	1		Airbag	
Abrasion, left side of face from cheek to jaw	1		Airbag	
Contusion, left hand	1		Airbag	Roof (airbag fling)
Maximum A.I.S. Level	1			
	_			
Injury Severity Score	<u>2</u>
